Manhole Inspection Summary

Manhole # S21AA1023MH

Record Plat: **21AA1** Node: **023** Status: **New Manhole (Not in GIS)** Insp Date: **3/21/07 10:46 AM**

Location Address: **2097 PARKDALE AVE**

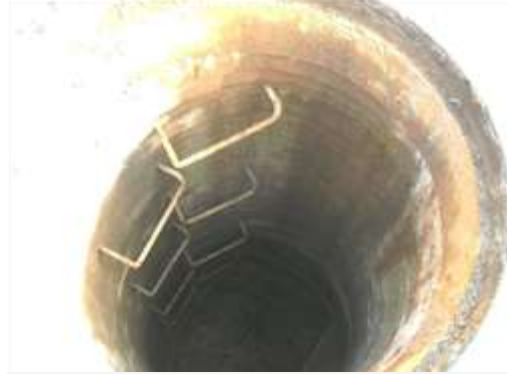
Comments **The Top View photo does not show a Channel due to the overhang and placement of the Out pipe.**

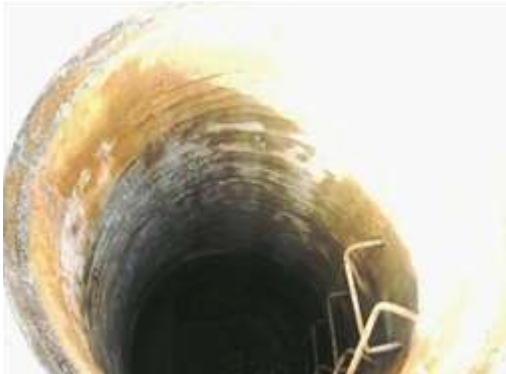
Defect

☒ **Leaks**

Infiltration: ☐ None ☒ **Joint** ☐ Cracks ☒ **Mortar** ☐ Roots ☐ Wall

Infiltration: ☐ None ☐ Joint ☐ Cracks ☒ **Mortar** ☐ Roots ☒ **Wall**

Frame leaks. Adjustment, Corbel and Barrel infiltration.

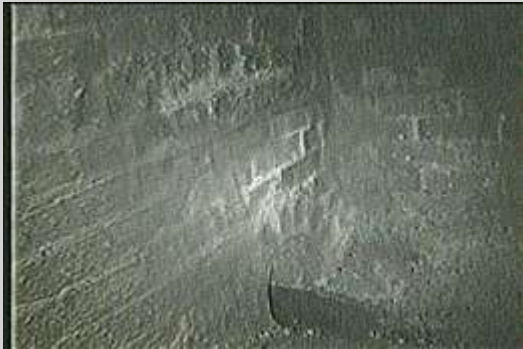
8 in. Circular Gravity Sewer
Pipe Out @ 12 O'Clock

Rod and Bar (Angled)

Pipe Material: **Unknown**

Invert Depth: **15.05** (ft.) Flow Characteristics: **None**

Infiltration: **None**
